2016 Oyster Reef Restoration Project Funded by the Aquatic Resources
Mitigation Program

Oyster Reef Restoration in Great Bay Estuary

FINAL REPORT - March 31, 2017

Jackson Estuarine Laboratory, University of New Hampshire, Durham, NH 03824

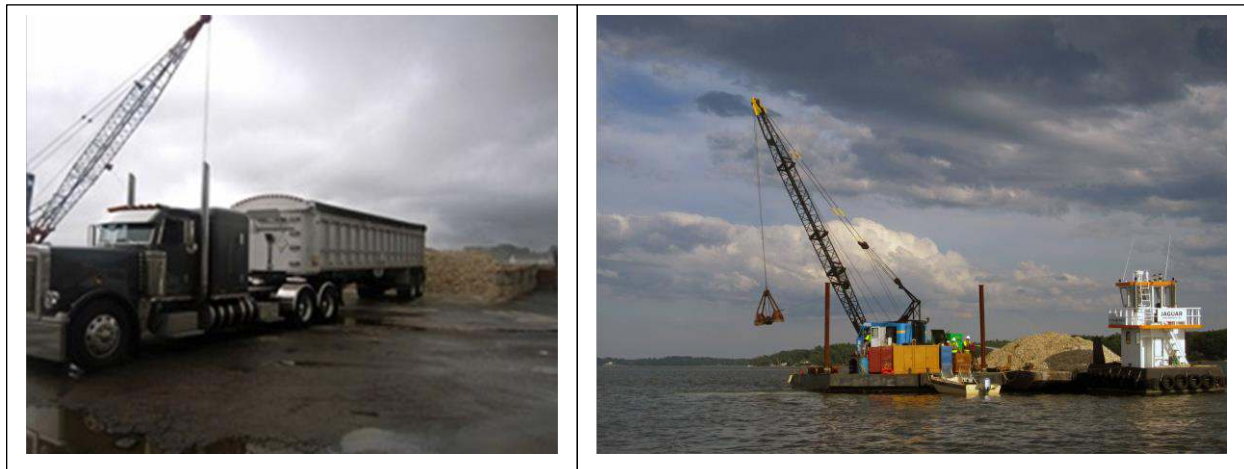
Fig. 3. Shell delivery by truck at Granite State Minerals, and reef shell base construction by Riverside and Pickering Marine.

Bid requests were received from Riverside and Pickering Marine and Pepperrell Cove Marine on May 20, 2016. The award for construction of the reef shell base subsequently was made to Riverside and Pickering. Arrangements were also made with M&W Livestock for shell delivery, and with Granite State Minerals for temporary shell storage and handling. Approximately 500 yd³ of seasoned (6 months) surf clam shell was delivered to Granite State Minerals, and reef base construction occurred on July 18 - 21, 2016 (Fig. 3).

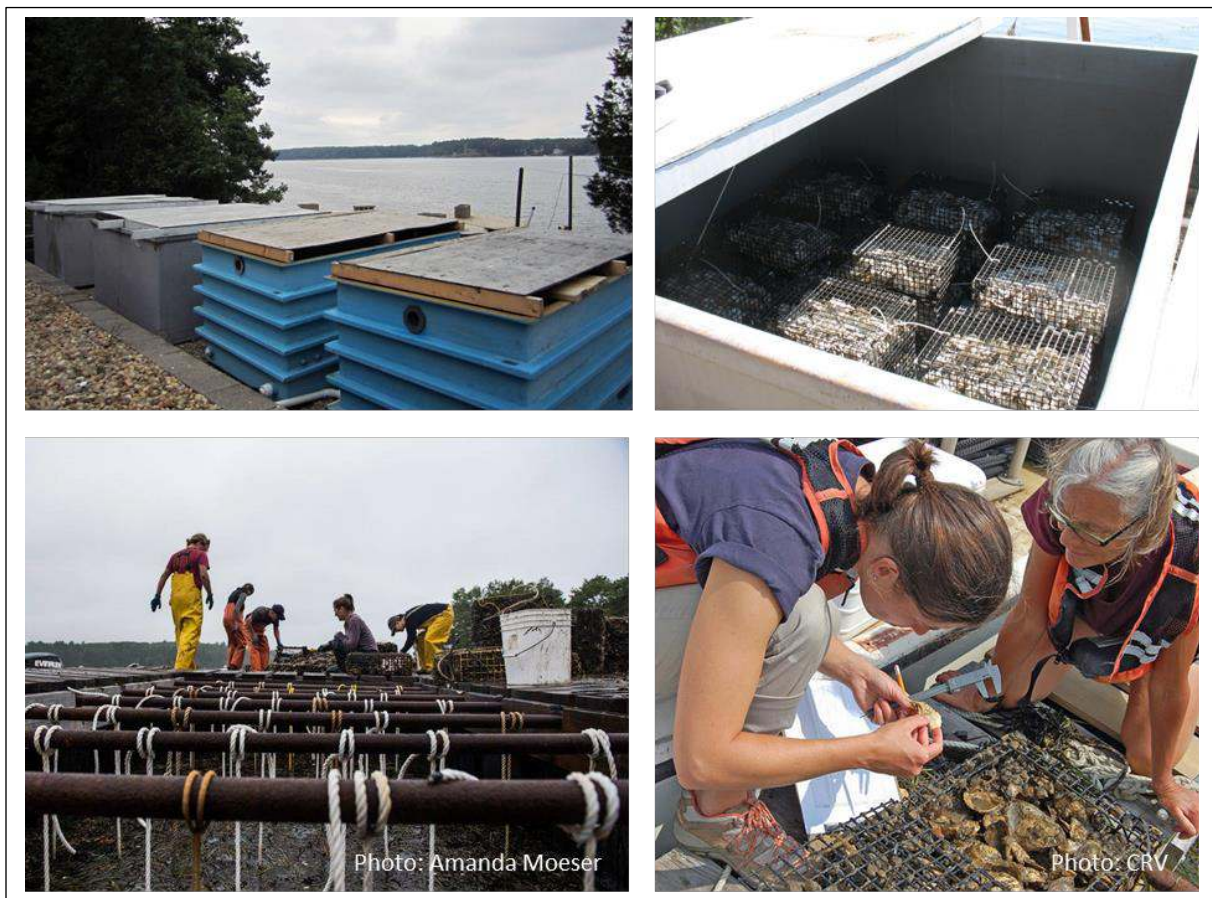
Fig. 4. Overview of SOS production showing remote setting tanks with seasoned shell in cages (upper photos) and maintaining spat on nursery raft (lower photos).

Preparation of seasoned, recycled oyster shell and the remote setting tanks at Jackson Estuarine Laboratory occurred on June 15 – 21, 2016 (Fig. 4). Approximately 12 million oyster larvae were received on June 22, 2016 and placed into the remote setting tanks. The resulting live oyster SOS were moved from the remote setting tanks to the nursery rafts in Adams Cove on June 27, 2016.

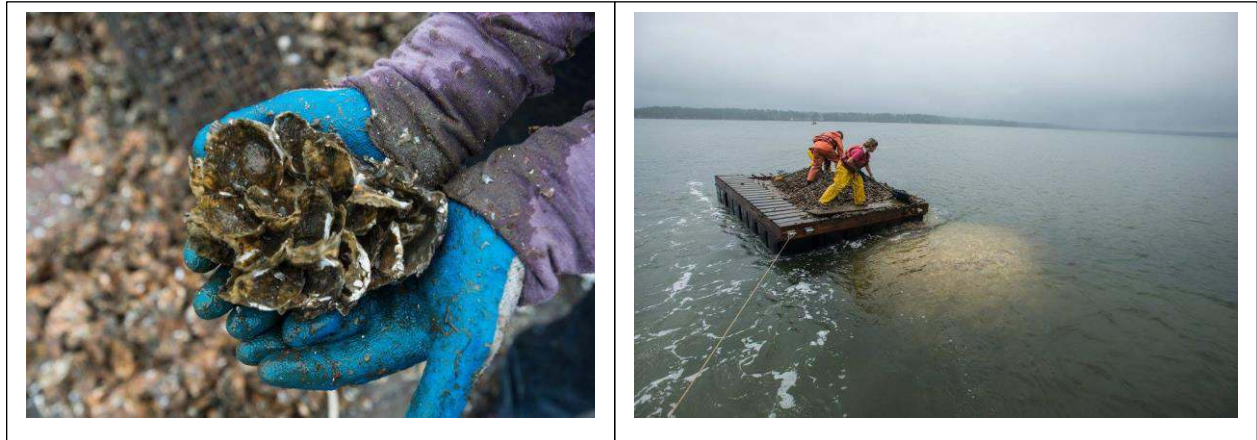
Fig. 5. Spreading SOS onto the shell mounds.

Initial counts (after the third day) of live SOS in the remote setting tanks indicated successful settlement of ~4.6 million of the 12 million larvae originally placed into the tanks (=38% setting success). After 9.5 weeks on the nursery rafts, the SOS were removed from the rafts and deposited onto the shell base at the restoration site on August 30, 2016 (Fig. 5). At that time, live SOS averaged 11.8 (± 1.14 ; 1 SE) spat per individual dead oyster shell (cultch) yielding a total of ~660,000 live oysters (SOS) with a mean size (shell height) of 15.7 mm (± 0.31 ; 1 SE) placed onto
